**Flood Control Project Maintenance
Levee Inspections****LMA District Cover Sheet****Spring 2015 Levee Inspection Results****Reclamation District No. 2091 Chase**

Levee Inspection Report By Mile - Spring 2015

Reclamation District No. 2091 Chase

Waterway	Bank	Unit Miles	Inspection Start/End	Inspector
Unit No. 01 San Joaquin River	Right	7.46	05/26/2015 05/26/2015	Richard Willoughby

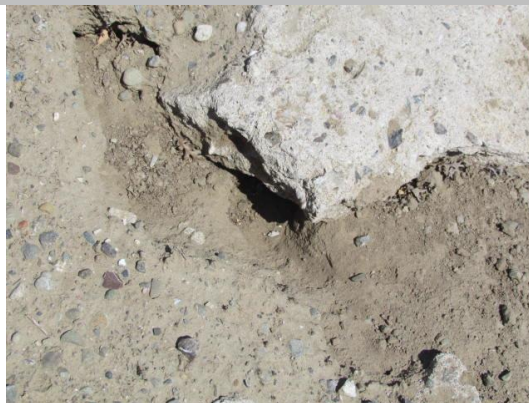
Photo 1 of 1 : SP_2015_RD2091_318_11_20150527_00008.jpg

LM Start	5.66	Rating **	M	Issue No.	11
LM End	5.68	Issue Type +	Ma	Location *	LS
Category	Earthen Levee			GPS Latitude/Longitude	
				Start	End
Item	Animal Control			37.486090 °	37.485839 °
				-121.067612 °	-121.067357 °
DWR ID	DWR_RD2091_01_s_2015_11				
Action/Comments					
No rodents visible, but rodent burrows visible; need to backfill and compact or grout burrows. Inspector Comments: Several rodent holes noted at the base of the tree on the landward toe.

Looking at typical view of rodent holes on the landward slope and toe.

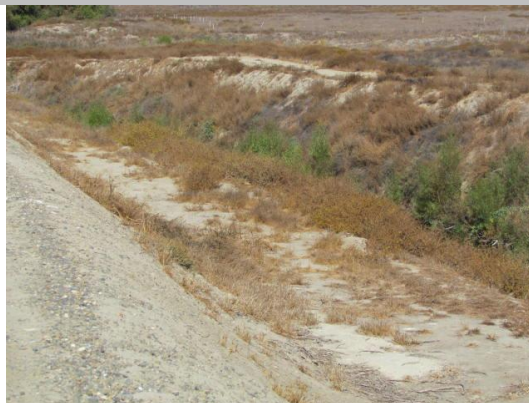
Photo 1 of 2 : SP_2015_RD2091_318_8_20150309_00001.jpg

LM Start	7.55	Rating **	U	Issue No.	8
LM End	7.55	Issue Type +	En	Location *	LS
Category	Earthen Levee			GPS Latitude/Longitude	
				Start	End
Item	Encroachments				°
					°
DWR ID	DWR_RD2091_01_f_2013_8				
Action/Comments					
Ditch					
Inspector Comments: Ditch has been in place for several years. Ditch is 10' to 15' from the landward toe and is 15" to 20' deep.

Looking east at drainage ditch at landward toe.

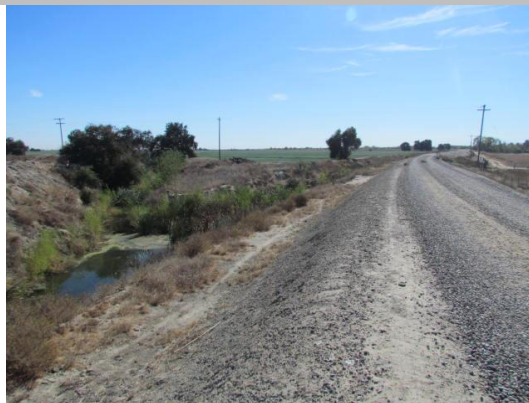
Photo 2 of 2 : SP_2015_RD2091_318_8_20150309_00002.jpg

Looking southeast at drainage ditch at landward toe.

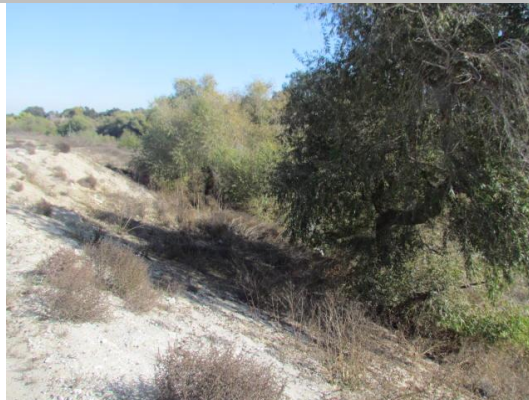
Photo 1 of 2 : SP_2015_RD2091_319_1_20150309_00001.jpg

LM Start	0.03	Rating **	M	Issue No.	1
LM End	0.03	Issue Type +	Ma	Location *	WS
Category	Earthen Levee			GPS Latitude/Longitude	
				Start	End
Item	Trim / Thin Trees			37.482523 °	37.482523 °
				-121.051103 °	-121.051103 °
DWR ID	DWR_RD2091_02_s_2012_1				
Action/Comments					
Thin trees to allow visibility of the ground and room to flood fight.

Looking east at untrimmed trees on waterward slope. (Fall 2014)

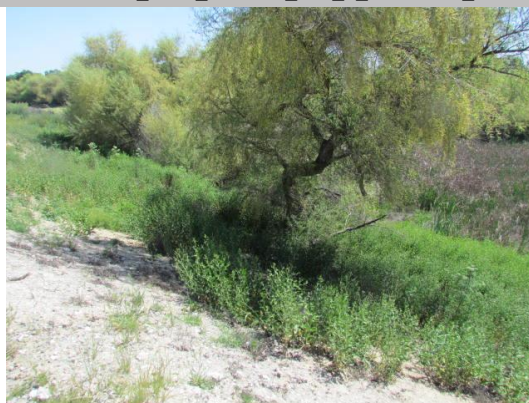
Photo 2 of 2 : SP_2015_RD2091_319_1_20150309_00002.jpg

Looking east at untrimmed tree on waterward slope. (Spring 2014)

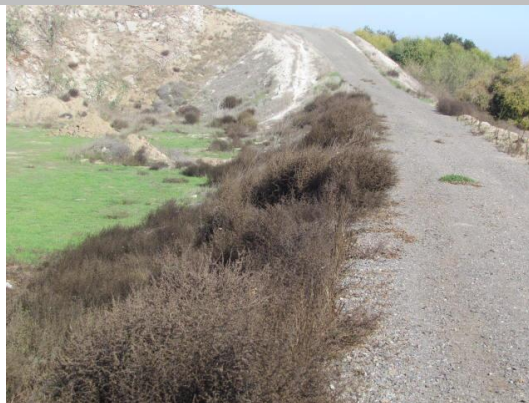
Photo 1 of 1 : SP_2015_RD2091_319_2_20150309_00003.jpg

LM Start	0.05	Rating **	M	Issue No.	2
LM End	0.10	Issue Type +	Ma	Location *	LS
Category	Earthen Levee			GPS Latitude/Longitude	
				Start	End
Item	Vegetation			37.482815 °	37.483306 °
				-121.050849 °	-121.050302 °
DWR ID	DWR_RD2091_02_f_2012_2				
Action/Comments					
Remove the wild growth other than native grasses from the levee slopes.					
Inspector Comments: Control tumble weeds on landward slope.

Looking north at tumble weeds on landward slope.

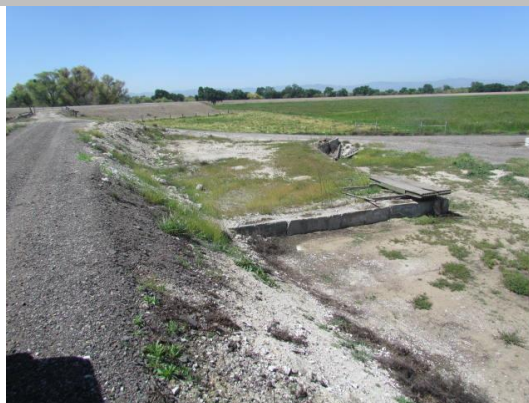
Photo 1 of 1 : SP_2015_RD2091_319_12_20150309_00011.jpg

LM Start	0.06	Rating **	M	Issue No.	12
LM End	0.06	Issue Type +	En	Location *	LS
Category	Earthen Levee			GPS Latitude/Longitude	
				Start	End
Item	Encroachments			37.482844 °	37.482844 °
				-121.050816 °	-121.050816 °
DWR ID	DWR_RD2091_02_s_2014_12				
Action/Comments					
Retaining Wall					
Inspector Comments: Concrete foundation on landward toe.

Looking west at concrete foundation/retaining wall at landward toe.

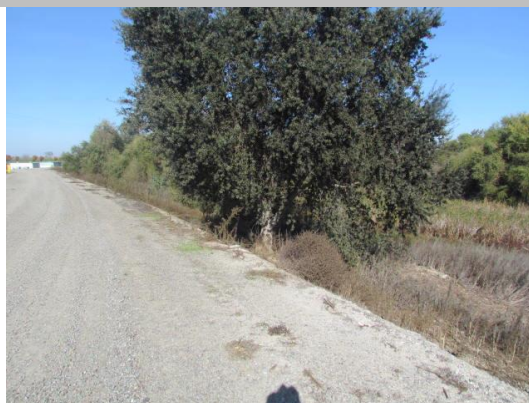
Photo 1 of 1 : SP_2015_RD2091_319_3_20150309_00004.jpg

LM Start	0.18	Rating **	M	Issue No.	3
LM End	0.18	Issue Type +	Ma	Location *	WS
Category	Earthen Levee			GPS Latitude/Longitude	
				Start	End
Item	Trim / Thin Trees			37.484342 °	37.484342 °
				-121.049848 °	-121.049848 °
DWR ID	DWR_RD2091_02_f_2012_3				
Action/Comments					
Trim trees to at least five feet above ground level.

Looking north at untrimmed tree on waterward slope.

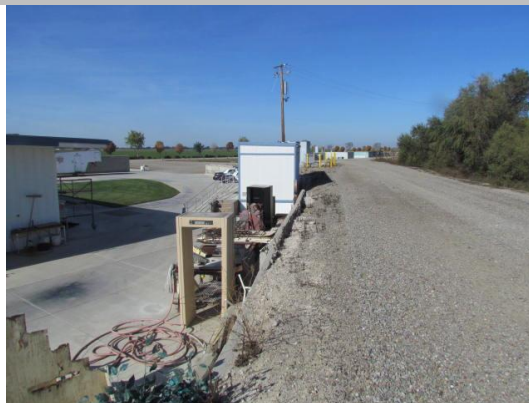
Photo 1 of 2 : SP_2015_RD2091_319_8_20150309_00009.jpg

LM Start	0.20	Rating **	M	Issue No.	8
LM End	0.25	Issue Type +	En	Location *	LS
Category	Earthen Levee			GPS Latitude/Longitude	
				Start	End
Item	Encroachments			37.484565 °	37.485283 °
				-121.049980 °	-121.050252 °
DWR ID	DWR_RD2091_02_f_2013_8				
Action/Comments					
Equipment					
Inspector Comments: Several items stored at landward toe.

Looking north at several items at landward toe.

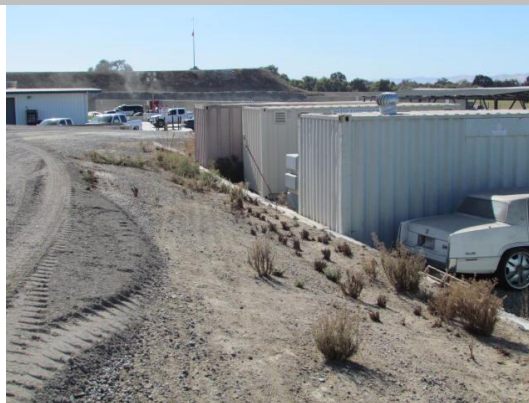
Photo 2 of 2 : SP_2015_RD2091_319_8_20150309_00010.jpg

Looking northeast at storage containers and abandoned vehicle at landward toe.

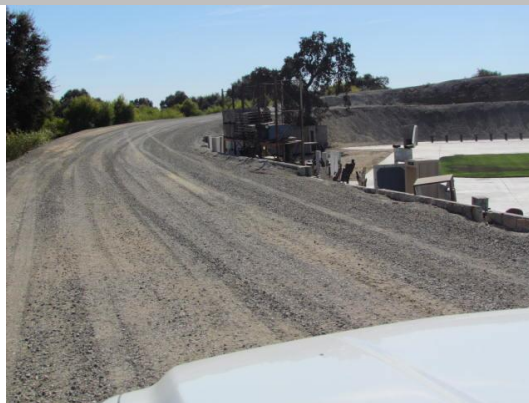
Photo 1 of 2 : SP_2015_RD2091_319_6_20150309_00006.jpg

LM Start	0.20	Rating **	M	Issue No.	6		
LM End	0.20	Issue Type +	En	Location *	LS		
Category	Earthen Levee			GPS Latitude/Longitude			
				Start		End	
Item	Encroachments				°		°
					°		°
DWR ID	DWR_RD2091_02_f_2013_6						
Action/Comments							
Retaining Wall							
Inspector Comments: Retaining walls have been in place for several years.

Looking northeast at retaining walls within the City of Modesto shooting range on landward slope and toe.

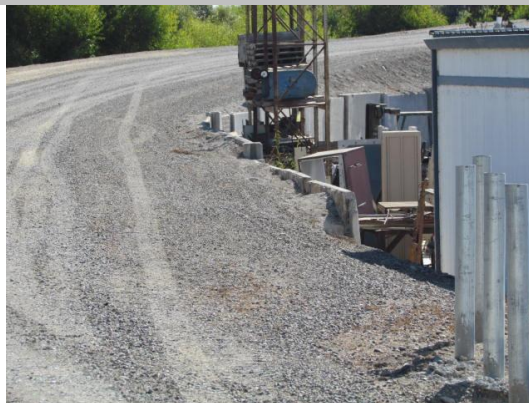
Photo 2 of 2 : SP_2015_RD2091_319_6_20150309_00007.jpg

LM Start	0.20	Rating **	M	Issue No.	6 (cont)		
LM End	0.20	Issue Type +	En	Location *	LS		
Category	Earthen Levee			GPS Latitude/Longitude			
				Start		End	
Item	Encroachments				°		°
					°		°
DWR ID	DWR_RD2091_02_f_2013_6						
Action/Comments							
Retaining Wall							
Inspector Comments: Retaining walls have been in place for several years.

Looking east at retaining walls on landward toe.

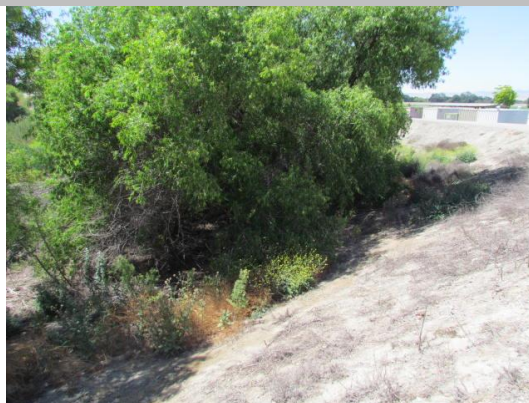
Photo 1 of 1 : SP_2015_RD2091_319_14_20150527_00013.jpg

LM Start	0.23	Rating **	M	Issue No.	14
LM End	0.27	Issue Type +	Ma	Location *	WS
Category	Earthen Levee			GPS Latitude/Longitude	
				Start	End
Item	Trim / Thin Trees			37.484917 °	37.485418 °
				-121.050224 °	-121.049933 °
DWR ID	DWR_RD2091_02_s_2014_14				
Action/Comments					
Trim trees to at least five feet above ground level.					
Inspector Comments: Control trees on waterward slope.

Looking northeast at untrimmed tree on waterward slope.

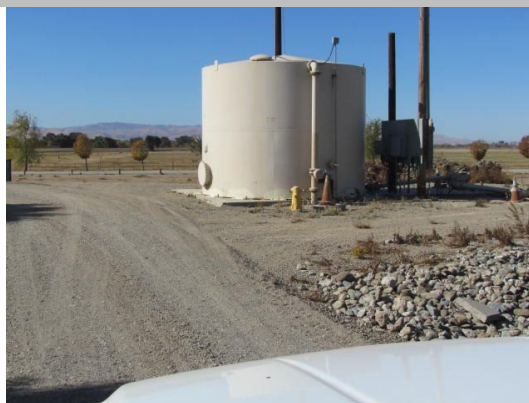
Photo 1 of 1 : SP_2015_RD2091_319_7_20150309_00008.jpg

LM Start	0.25	Rating **	M	Issue No.	7
LM End	0.25	Issue Type +	En	Location *	LS
Category	Earthen Levee			GPS Latitude/Longitude	
				Start	End
Item	Encroachments				°
					°
DWR ID	DWR_RD2091_02_f_2013_7				
Action/Comments					
Tank					
Inspector Comments: Water tank has been in place for several years.

Looking west at water tank on landward shoulder.

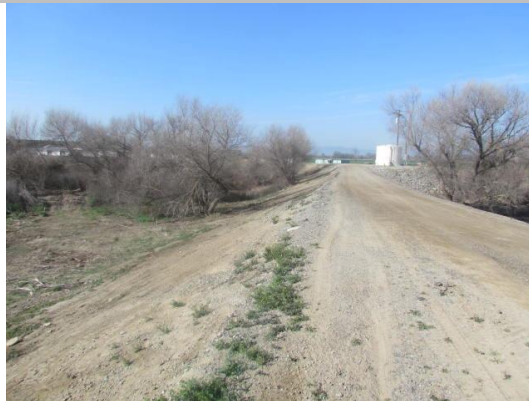
Photo 1 of 1 : SP_2015_RD2091_319_4_20150309_00005.jpg

LM Start	0.28	Rating **	M	Issue No.	4
LM End	0.28	Issue Type +	Ma	Location *	LS
Category	Earthen Levee			GPS Latitude/Longitude	
				Start	End
Item	Trim / Thin Trees			37.485447 °	37.485447 °
				-121.049750 °	-121.049750 °
DWR ID	DWR_RD2091_02_f_2012_4				
Action/Comments					
Trim trees to at least five feet above ground level.

Looking east at trimmed trees on landside slope and toe.
